AFFTC-TD-69-4

FLIGHT PLANNING AND CONDUCT OF THE X-15A-2 ENVELOPE EXPANSION PROGRAM

JOHNNY G. ARMSTRONG
Aerospace Research Engineer

JULY 1969

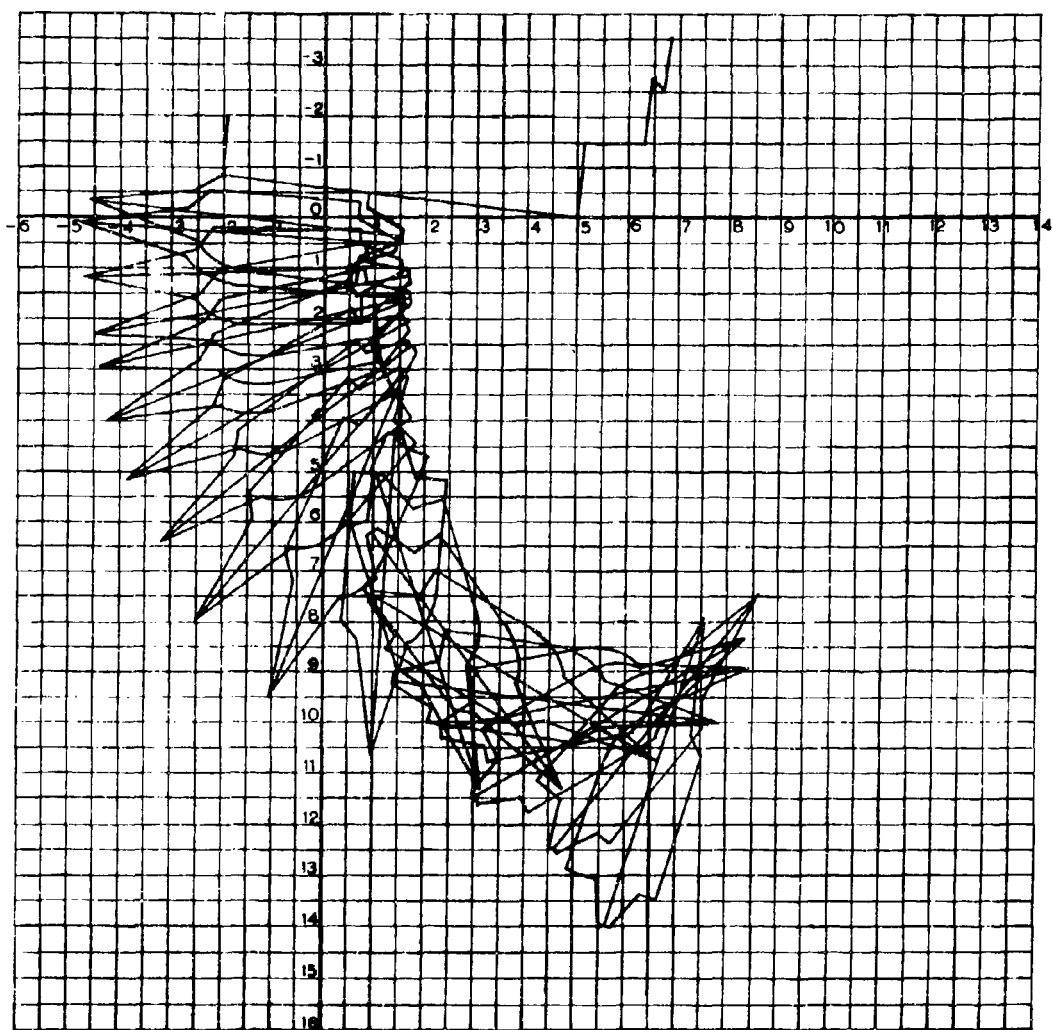
**Figure 27 FLIGHT 2-51-92 DUMMY RAMJET SEPERATION FROM MOBILE TRACKER
PICTURES**

On final approach the pilot jettisoned the ramjet, and there were no aircraft trim changes associated with the event. Ramjet separation characteristics were calculated by the contractor and under certain conditions the ramjet could recontact the aircraft, therefore a recommended ejection envelope and cg limits for the unit were established. To obtain data on the actual ramjet separation, a mobile tracker with telescopic cameras was located normal to the final approach track at the point of expected ramjet ejection. The pictures obtained were excellent and detailed analysis of the film was possible (figure 27). The agreement of the actual separation with the theoretical calculations was good, with the actual clearance being better than predicted (figure 28). The ramjet recovery system operation was unsatisfactory. The stranded cable attaching the recovery parachute to the ramjet failed as the chute deployed: however the impact damage was not major and the unit was refurbishable.

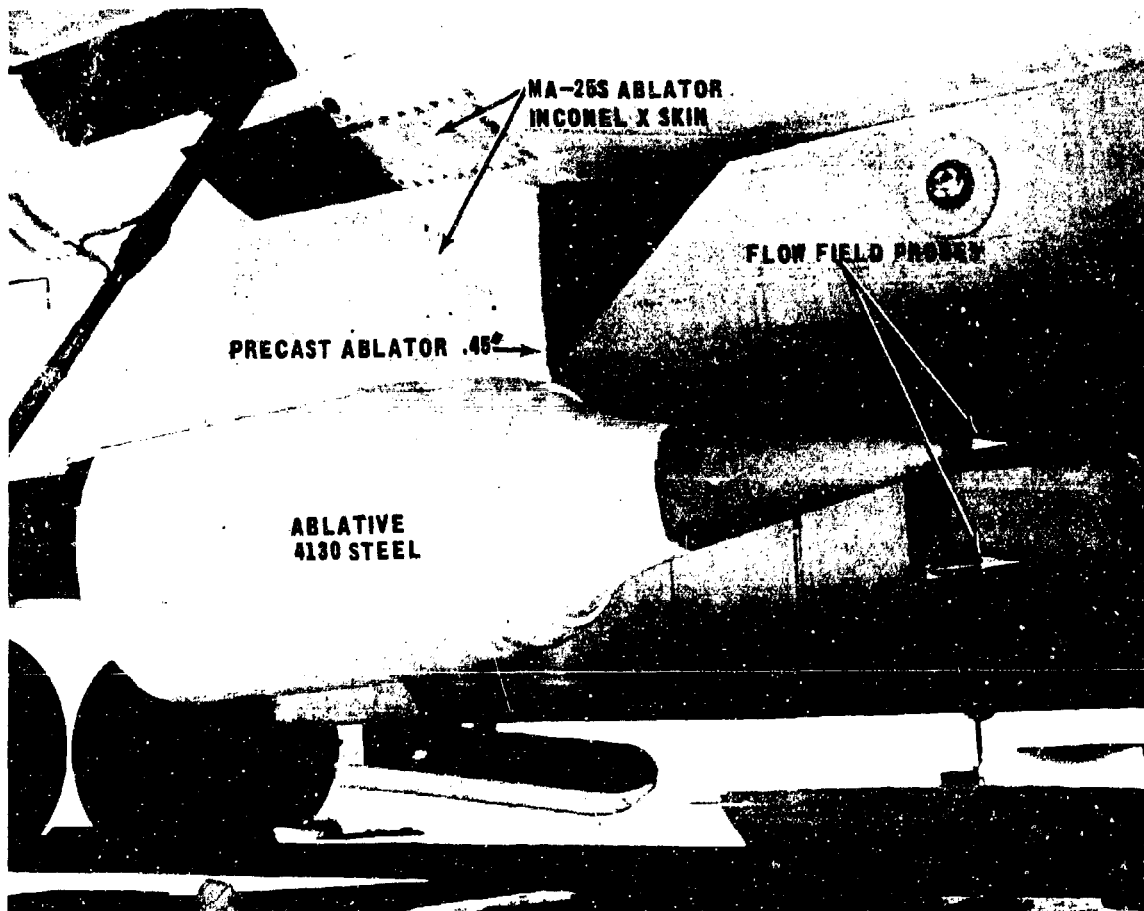
Figure 50 PRE-FLIGHT CONDITION OF RAMJET AND PYLON

The severe structural damage to the dummy ramjet and pylon during the flight to Mach 6.7 was the result of local aerodynamic heating due to shock impingement and flow interference effects. Figure 50 shows the preflight condition of the ramjet, pylon, and lower fuselage.
